# COASTLINE DESIGN, P.C.

## FLAG POND LIVING SHORELINE PROJECT

### PERMIT REPORT

May 15, 2018

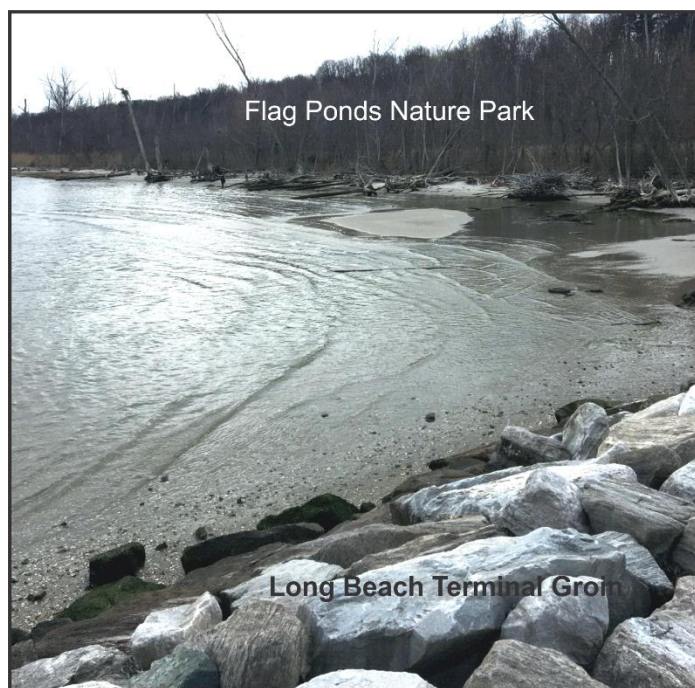
Figure 3. Present condition of Flag Ponds Nature Park shoreline (2017).
